### **Tech 2® Displaying All Zeroes for the Verification Numbers on the Calibration ID and Verification Number Screen**

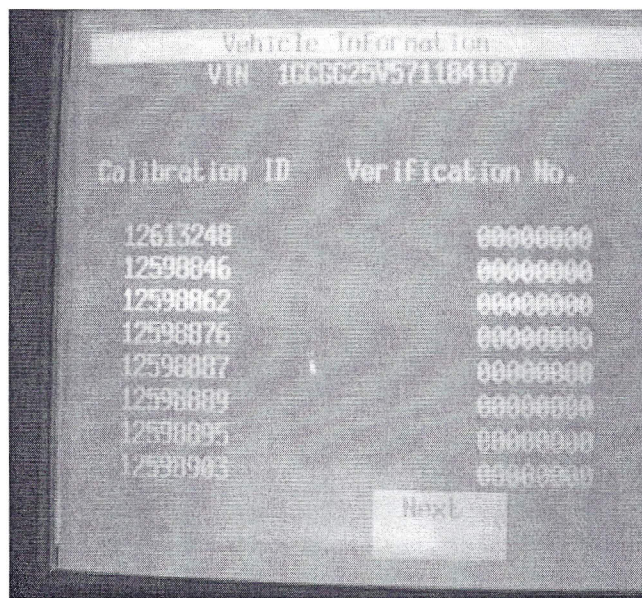
If the Tech 2® that you are using displays all zeroes for the Verification Numbers as shown, then perform the following steps:

- Update the Tech 2® with the latest software from TIS2WEB.
- Turn OFF the ignition for 90 seconds.
- Connect the Tech 2® to the vehicle.
- Turn ON the ignition, and build the vehicle. Observe the Tech 2® Calibration ID and Verification Number screen for proper operation.
  - If the Tech 2® screen still does not display properly, then turn OFF the ignition for 90 seconds again. Turn ON the ignition and observe the same screen for proper operation.
